# UP-EDGE-APL03

## Shock Test Report

Report NO: 22UP030010

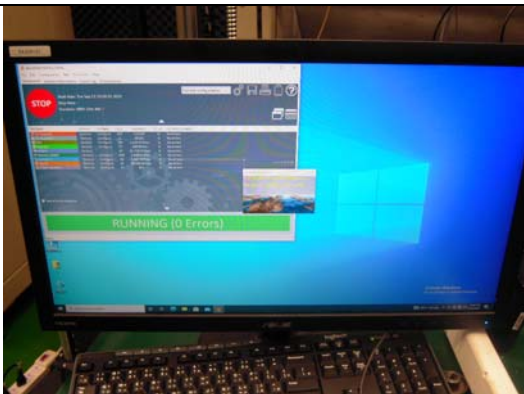
No structure deformation was found, and function was working normally.

**Normal**

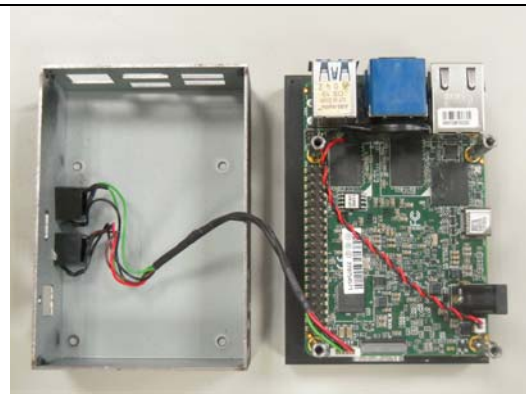
**Normal**
